Manhole Inspection Summary

Manhole # S31GG_050MH

Insp Date: **1/19/07 10:08 AM**

Location Address: **1204 JOHN ST**

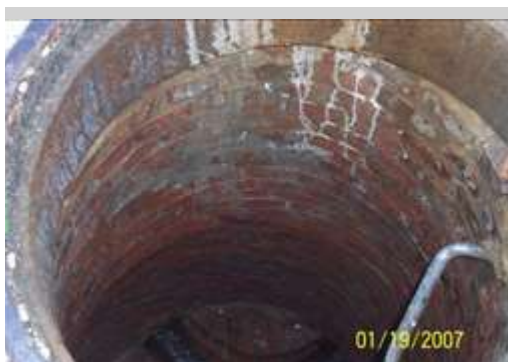
☐ Parged ☒ **Debris** (not Condition related)

☒ **Debris** (not Condition related)

Bench and Channel debris.

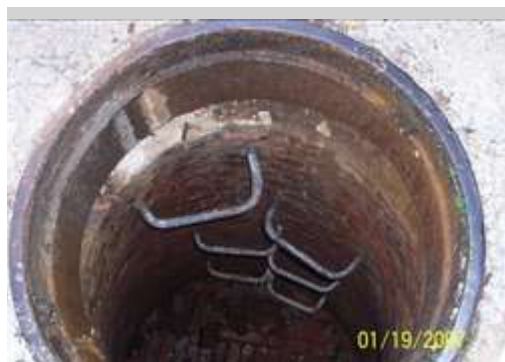
Infiltration: ☐ None ☒ **Joint** ☐ Cracks ☒ **Mortar** ☐ Roots ☐ Wall

Infiltration: ☐ None ☐ Joint ☐ Cracks ☒ **Mortar** ☐ Roots ☒ **Wall**

Adjustment deterioration and infiltration. Corbel and Barrel infiltration.

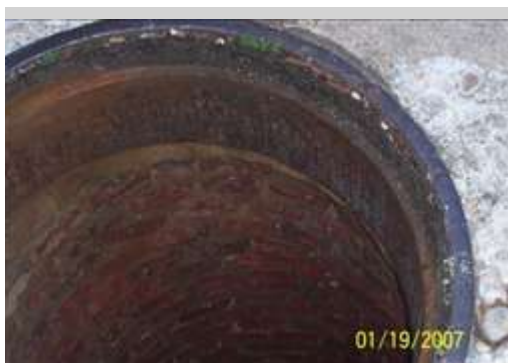
Frame Offset: **2** (in.)

☒ **Leaks**

Frame offset. Adjustment deterioration and infiltration. Corbel and Barrel infiltration - other side.

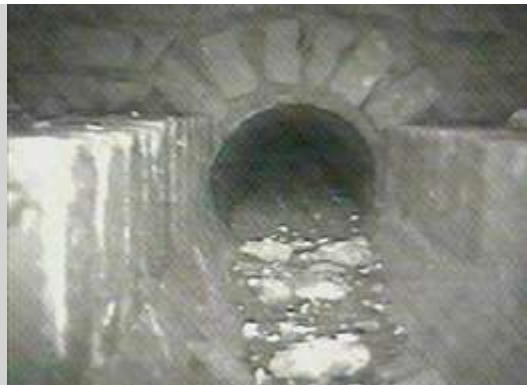
8 in. Circular Gravity Sewer Pipe In @ 6 O'Clock

Deposits: ☐ None ☒ **Mud** ☐ Sludge ☒ **Debris** ☐ Grease

Silt Depth: **2** (in.) Deposits Extent: **Light**

Infiltration: **Evidence** Pipe Seal Cond: **Unknown**

Connects To: **Stub connection / abandoned**
